LAKE CHATEAU DAM

BOONE COUNTY, MISSOURI

PHASE 1 INSPECTION REPORT NATIONAL DAM SAFETY PROGRAM

MAY, 1979

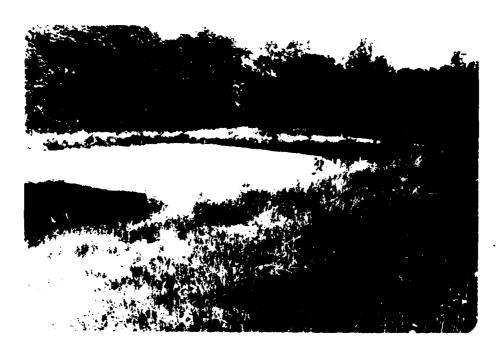
PHOTO NO. 8 - SEWAGE LAGOONS DOWNSTREAM ON LEFT.

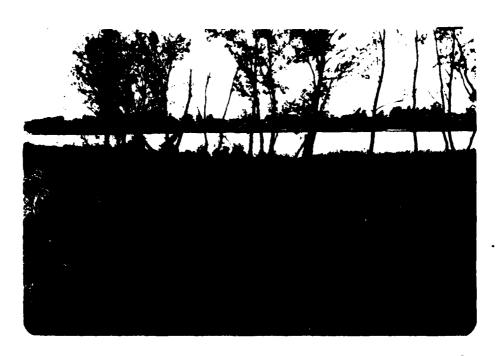
PHOTO NO. 12 - LOOKING UPSTREAM IN EMERGENCY SPILLWAY. TREES GROWING IN ENTRANCE.

- (1) Trees and shrubs growing on both embankment slopes should be removed and measures taken to prevent their recurrence. Removal and after-treatment of trees larger than 3 to 4 inches in diameter should be done under supervision of an engineer experienced in design and construction of earth dams.
- (2) Measures should be taken to repair and control the erosion on the upstream face of the dam.
- (3) A program of regular inspection and maintenance should be initiated to prevent and/or control the deficiencies discussed above. This program should include monitoring the seepage along the downstream toe to determine changes in amount and clarity of the effluent.
